Structural Intergrity Reserve Studies

Re: The Anchorage Condominiums

420 Moore Park Lane

UES Project No. 0311.2400001.0020

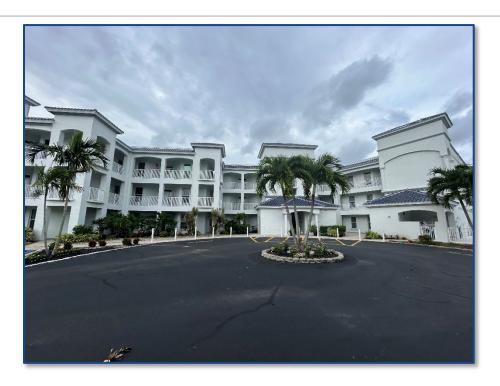
Photograph No. 1: Northern elevation

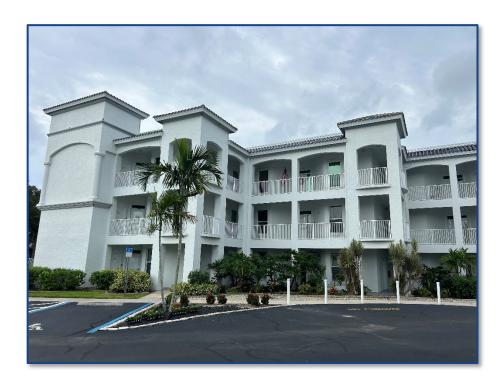
Photograph No. 2: Northern Elevation

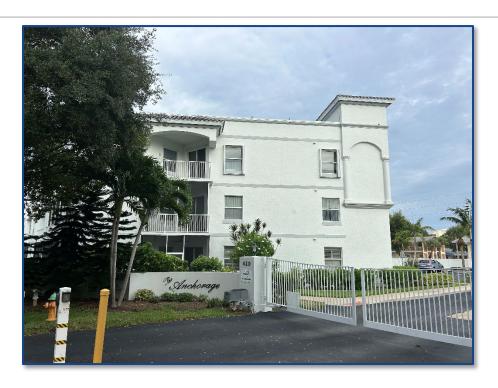
Photograph No. 3: Eastern elevation

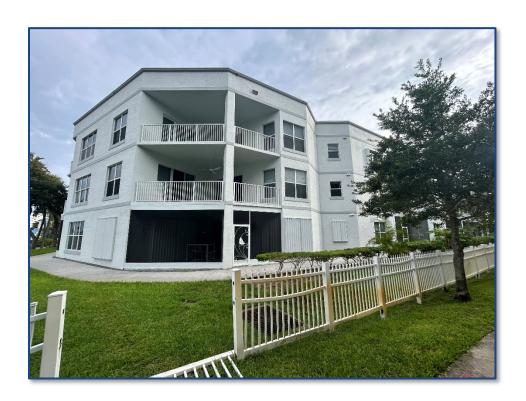
Photograph No. 4: Southwest corner elevation

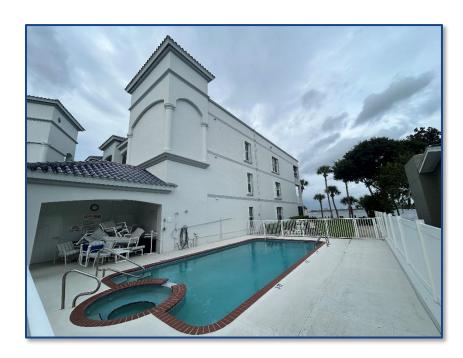
Photograph No. 5: Overall pool area at the northwest corner of the building.

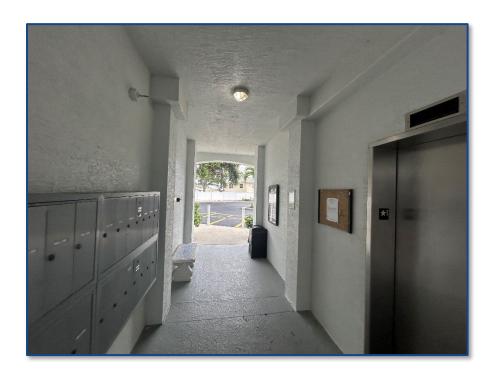
Photograph No. 6: Typical elevator door area at the first floor.

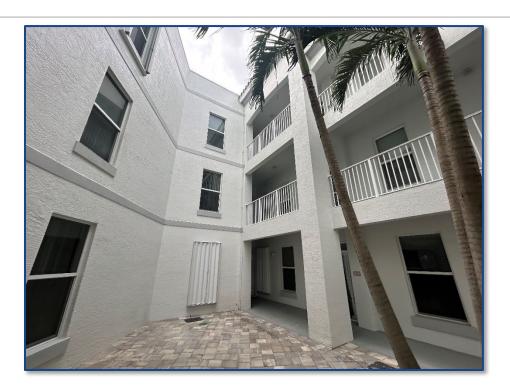
Photograph No. 7: Open area located at the center of the building.

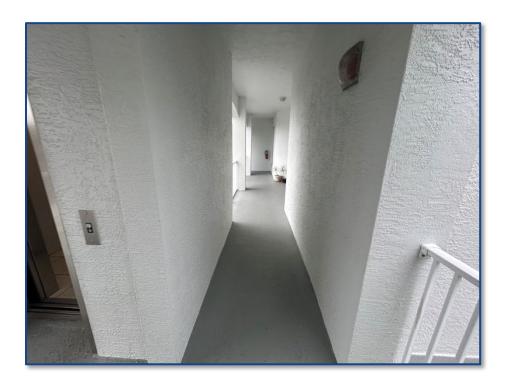
Photograph No. 8: Typical walkway between units.

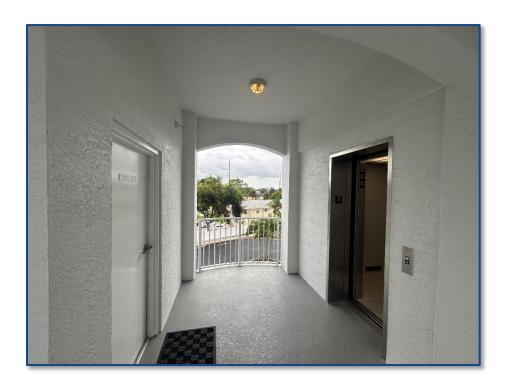
Photograph No. 9: Second floor typical elevator door opening area.

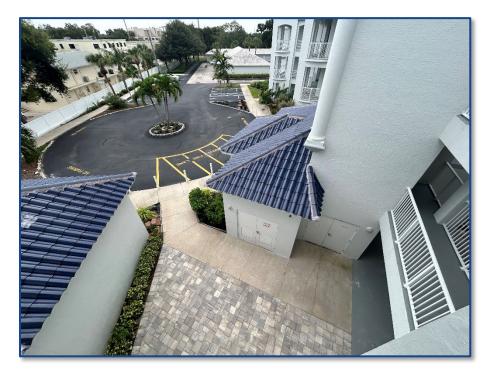
Photograph No. 10: Overview of the north side of the building.

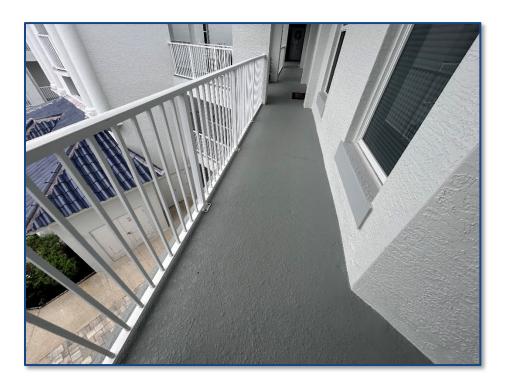
Photograph No. 11: Typical common walkway with aluminum railings.

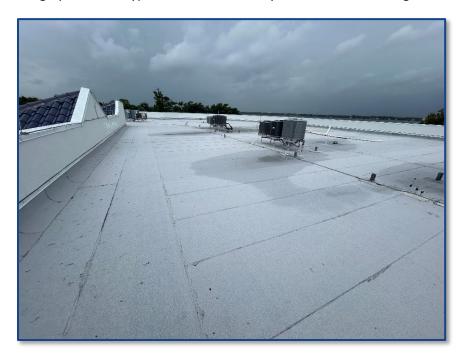
Photograph No. 12: West side of the roof overall facing south.

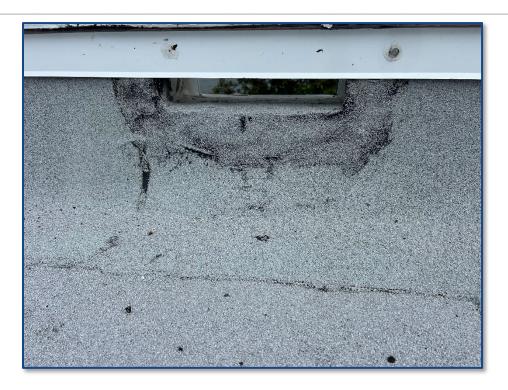
Photograph No. 13: Typical exterior roof scupper at the parapet wall.

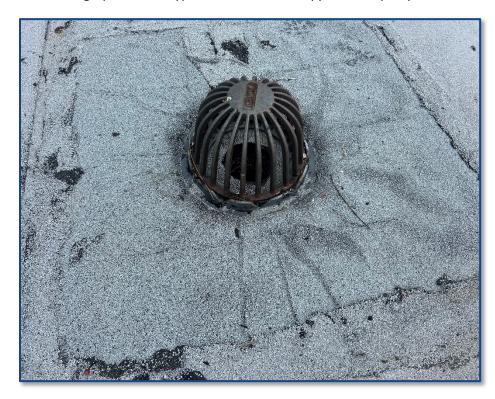
Photograph No. 14: Typical interior roof drain at the center of the roof.

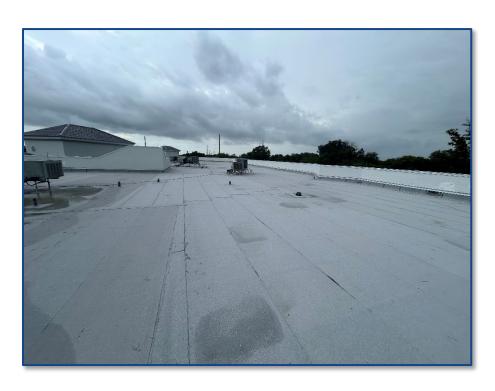
Photograph No. 15: Overall roof facing east.

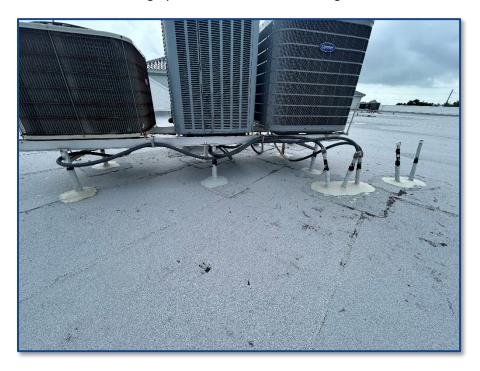
Photograph No. 16: AC stands mineral covered supports.

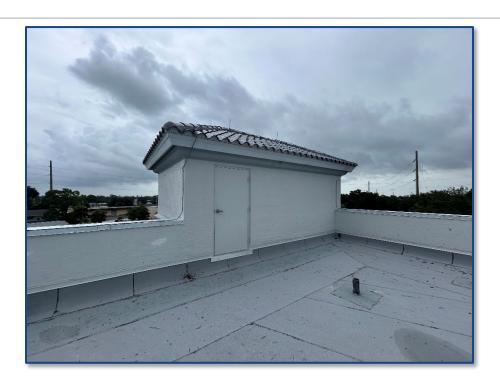
Photograph No. 17: Typical roof access from the stairwell at the east side of the roof.

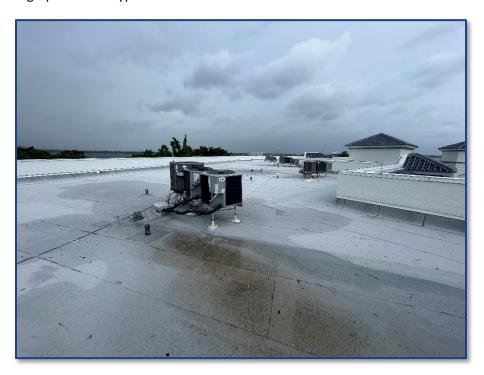
Photograph No. 18: Overall roof facing west in good condition.

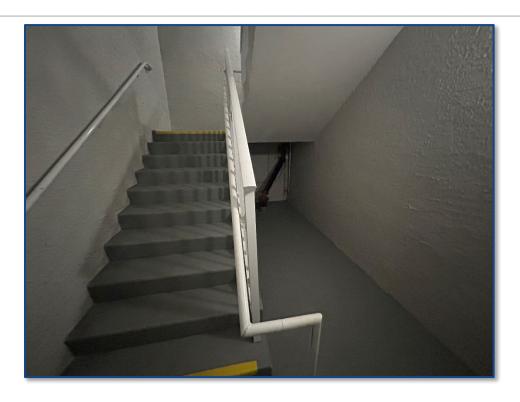
Photograph No. 19: Indoor stairwell located at the east side of the building.

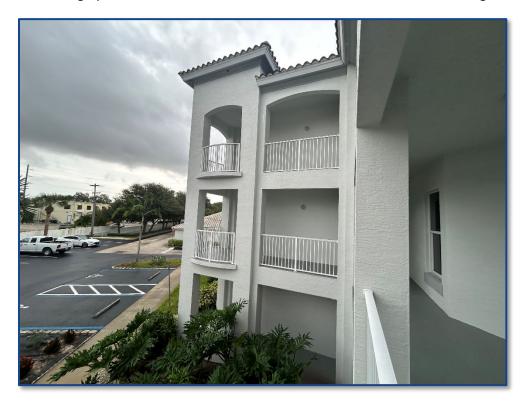
Photograph No. 20: Overview of outdoor walkways on the east side of the building.

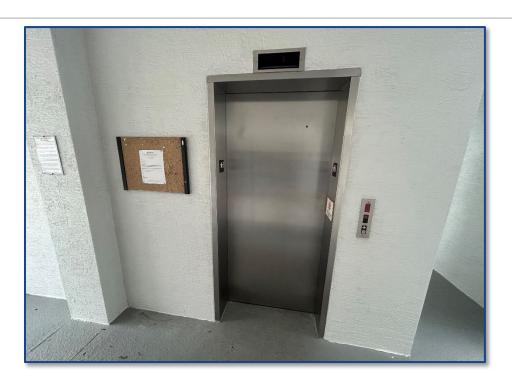
Photograph No. 21: Typical elevator door at center of building.

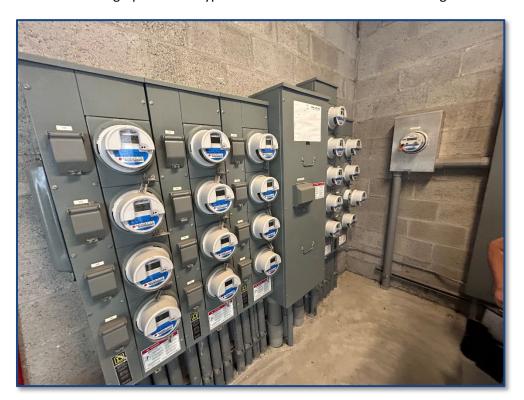
Photograph No. 22: Typical electrical meters and main service panel.

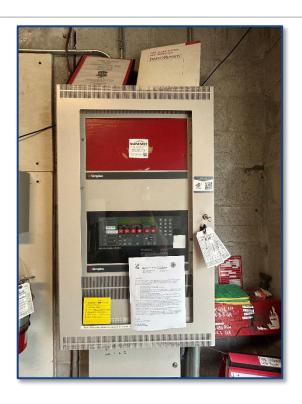
Photograph No. 23: Simplex Fire Alarm control panel located in the utility room.

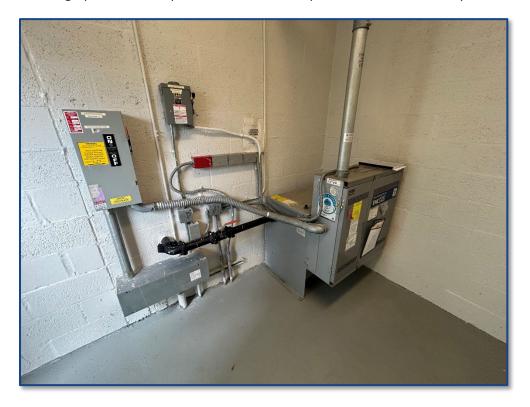
Photograph No. 24: Typical elevator hydraulic unit in the utility room.

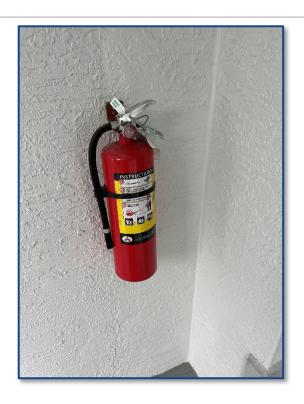
Photograph No. 25: Typical fire extinguisher located in walkway.

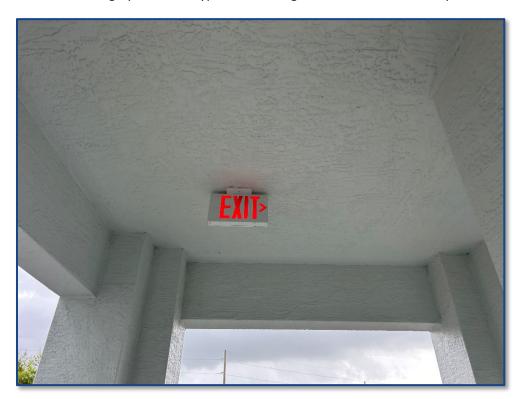
Photograph No. 26: Typical emergency exit signs located throughout walkway.

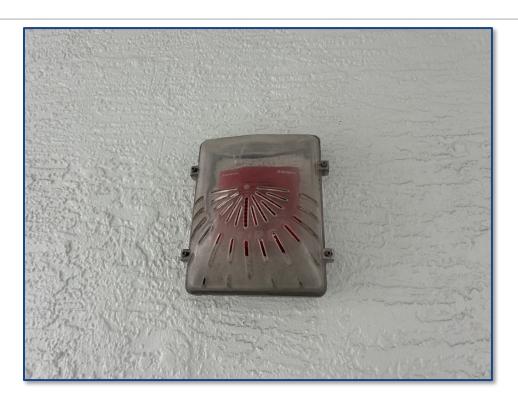
Photograph No. 27: Typical fire alarm located in walkway.

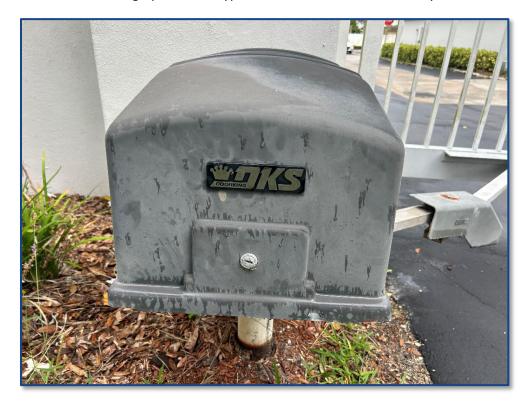
Photograph No. 28: Entrance gate motor at the south side of the property.
