Re: The Anchorage Condominiums  
420 Moore Park Lane  
Merritt Island, Florida 32952  
Brevard County Parcel ID 24-36-35-28-C-6.XA  
UES Project No. 0311.2400001.0020  
UES Document No.

UES Milestone Inspections, LLC (UES) has completed the mandatory Structural Integrity Reserve Study ("SIRS") as required for condominiums and cooperative buildings for the above referenced property. UES's assessment was performed in general accordance with Florida Statute (FS)718.112(2)(g) (or 719.106(3)(k) for Cooperatives) (effective May 26, 2022, and amended June 9, 2023) and local requirements of the Authority Having Jurisdiction (AHJ).

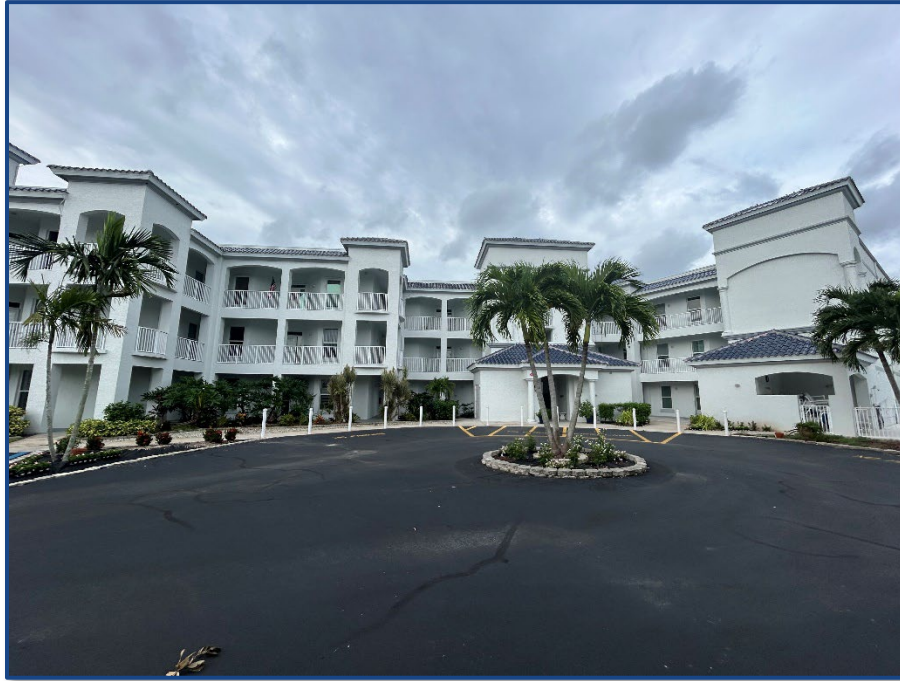
Photograph No. 1: Northern elevation

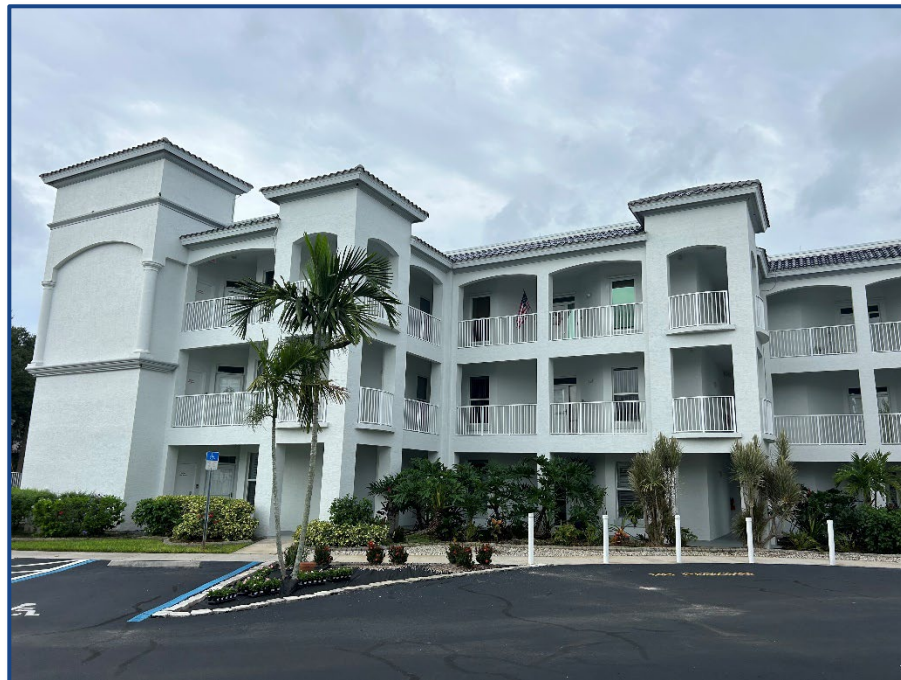
Photograph No. 2: Northern Elevation

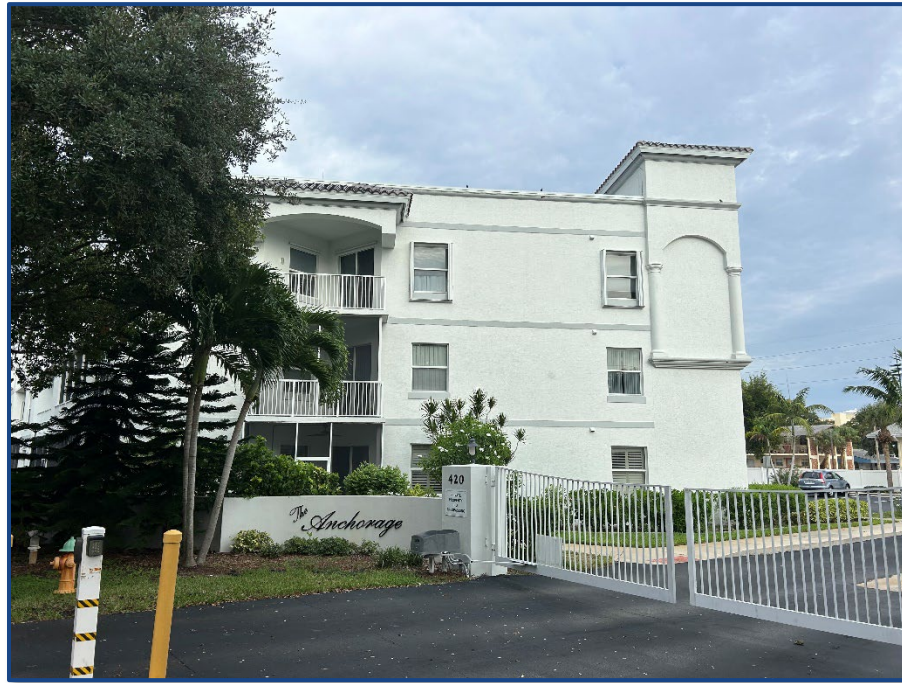
Photograph No. 3: Eastern elevation

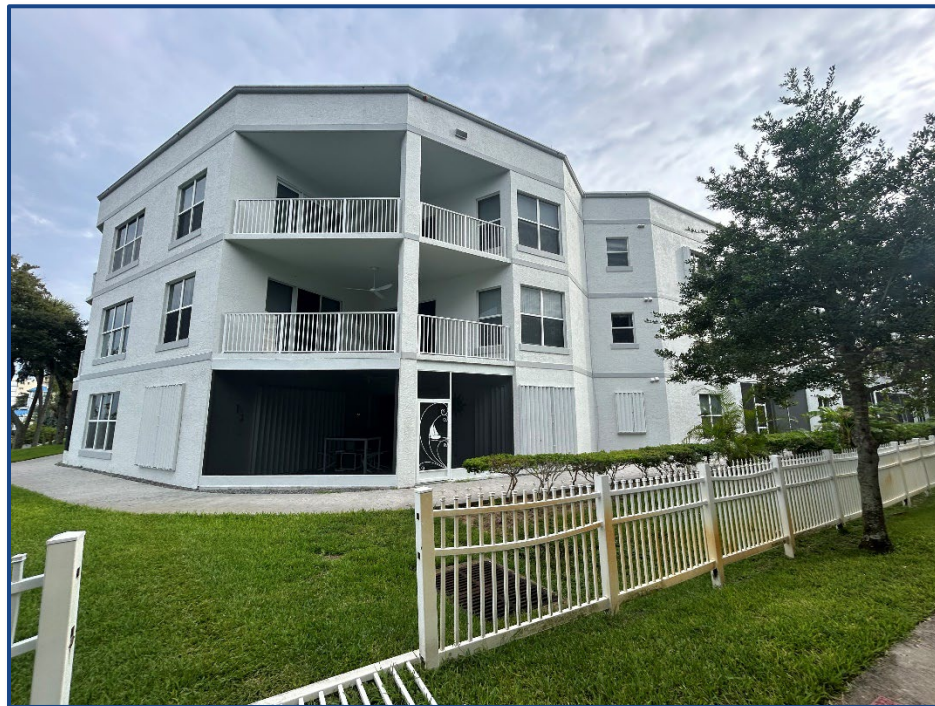
Photograph No. 4: Southwest corner elevation

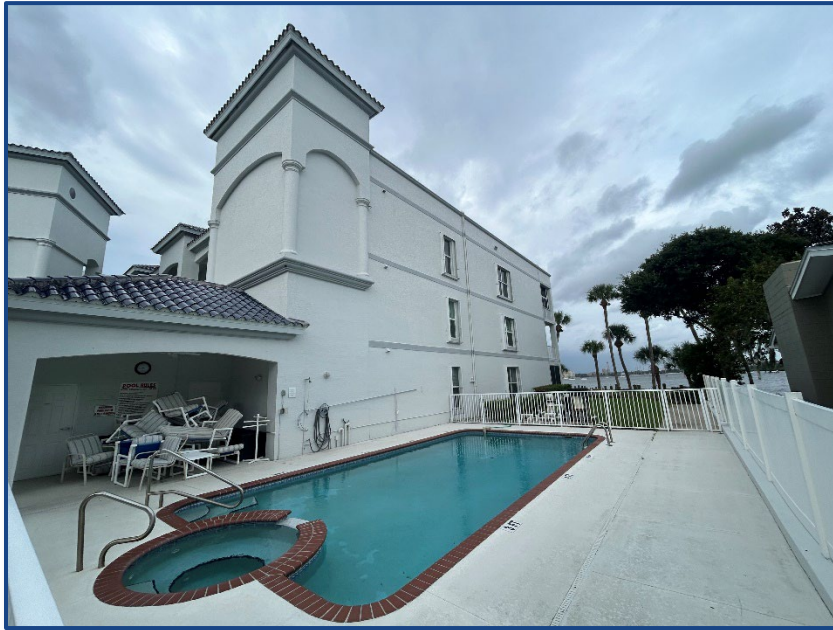
Photograph No. 5: Overall pool area at the northwest corner of the building.

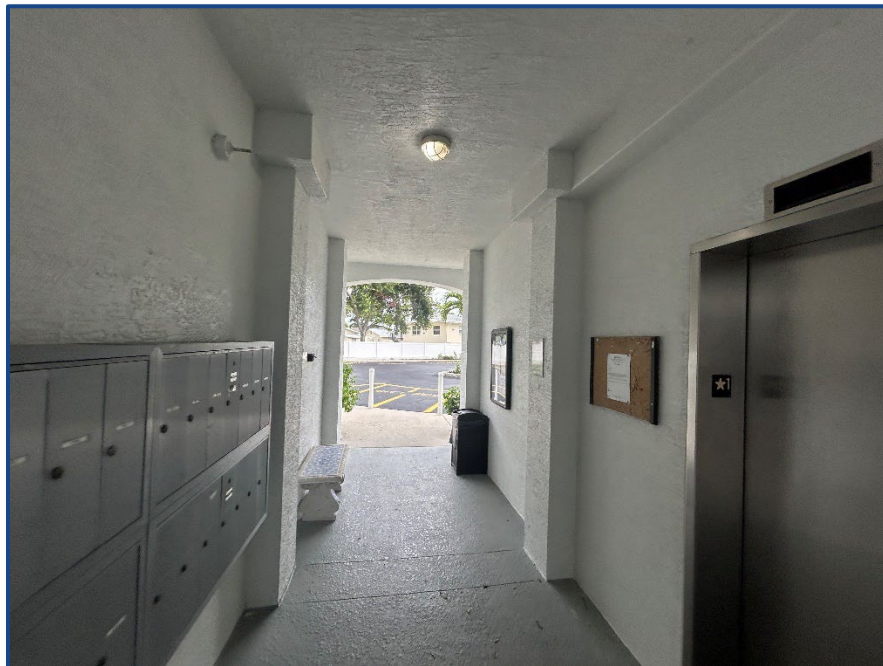
Photograph No. 6: Typical elevator door area at the first floor.

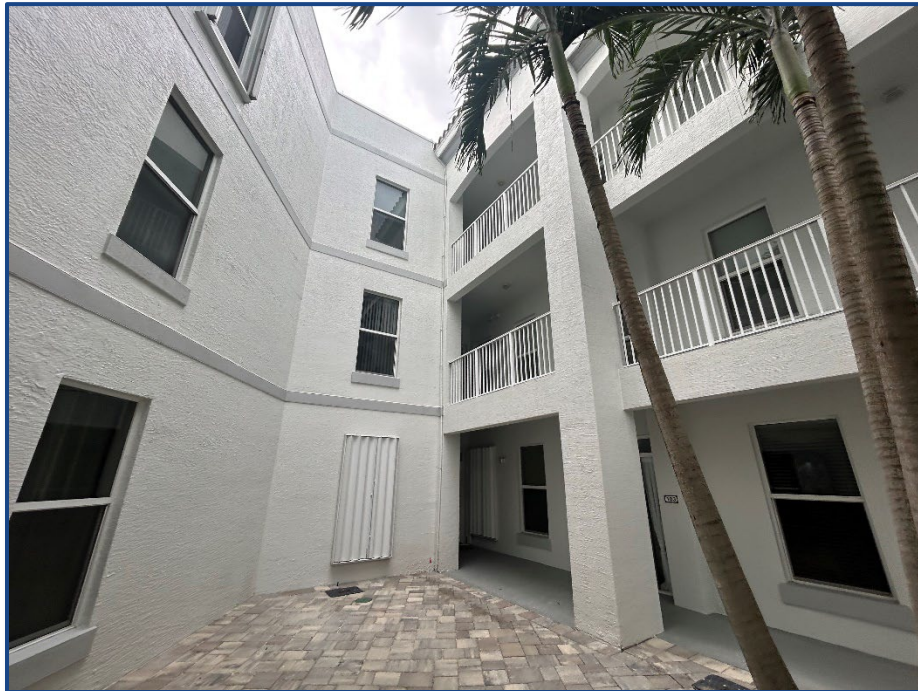
Photograph No. 7: Open area located at the center of the building.

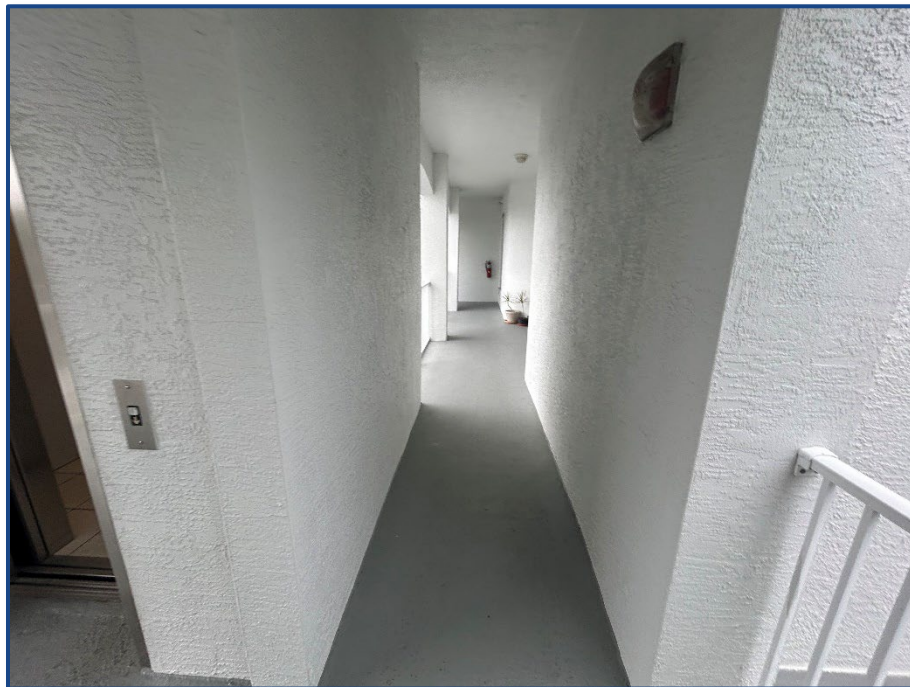
Photograph No. 8: Typical walkway between units.

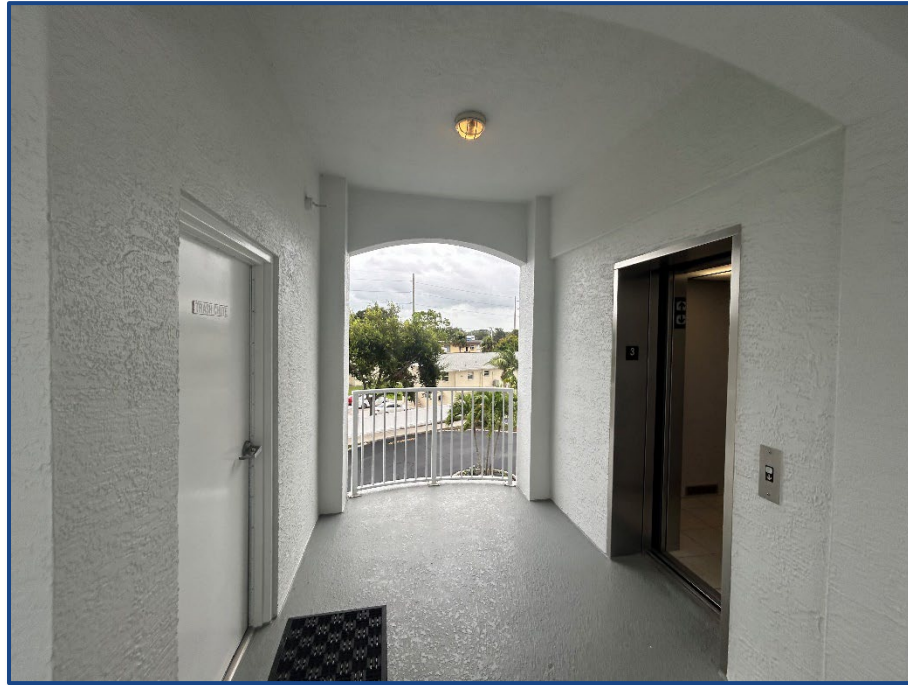
Photograph No. 9: Second floor typical elevator door opening area.

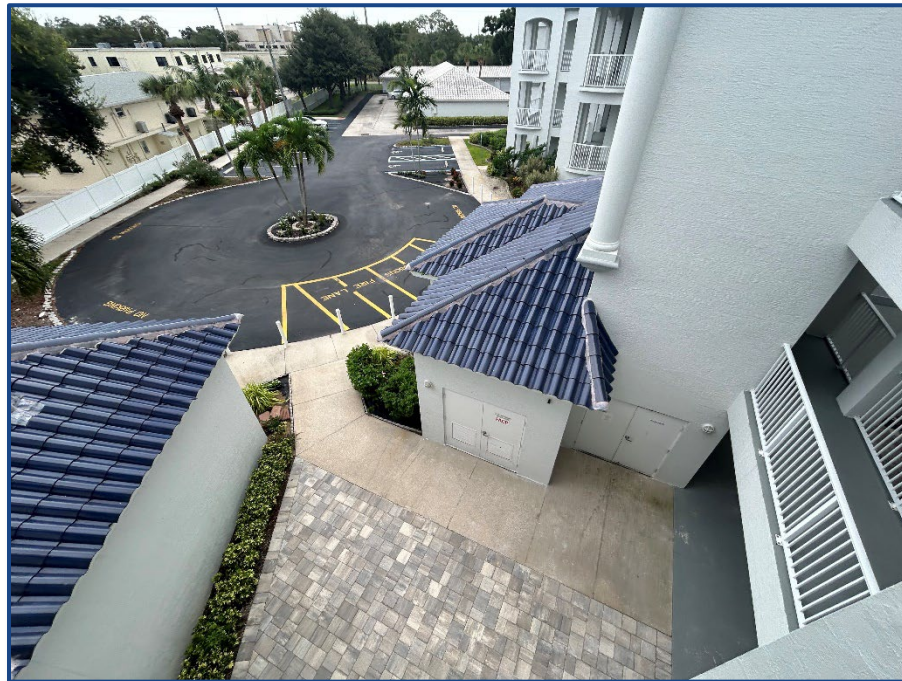
Photograph No. 10: Overview of the north side of the building.

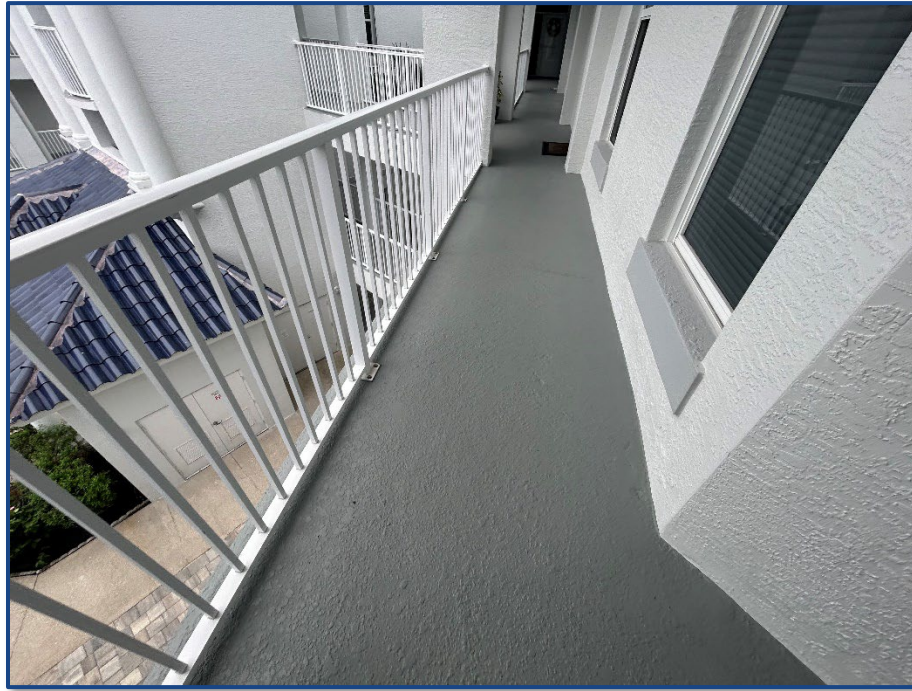
Photograph No. 11: Typical common walkway with aluminum railings.

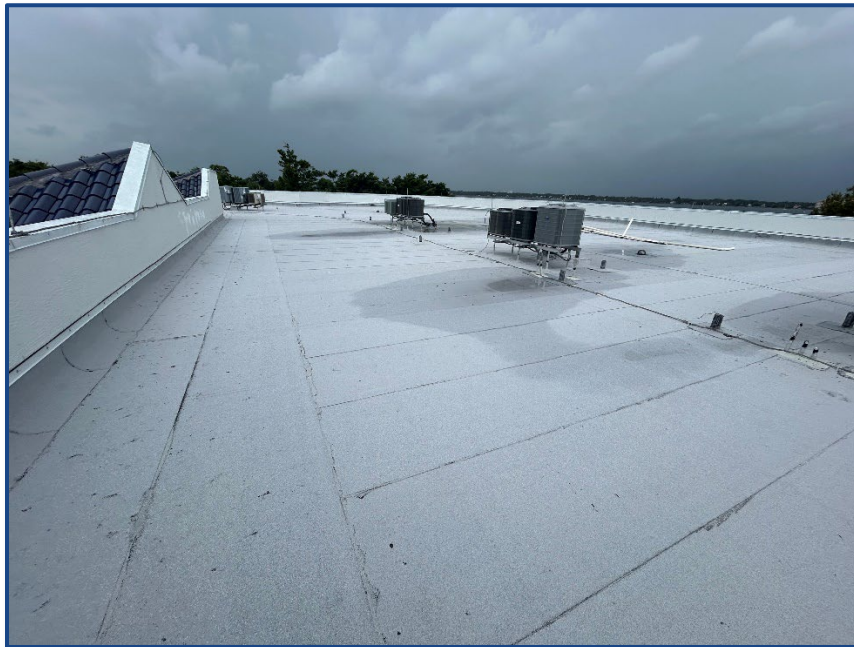
Photograph No. 12: West side of the roof overall facing south.

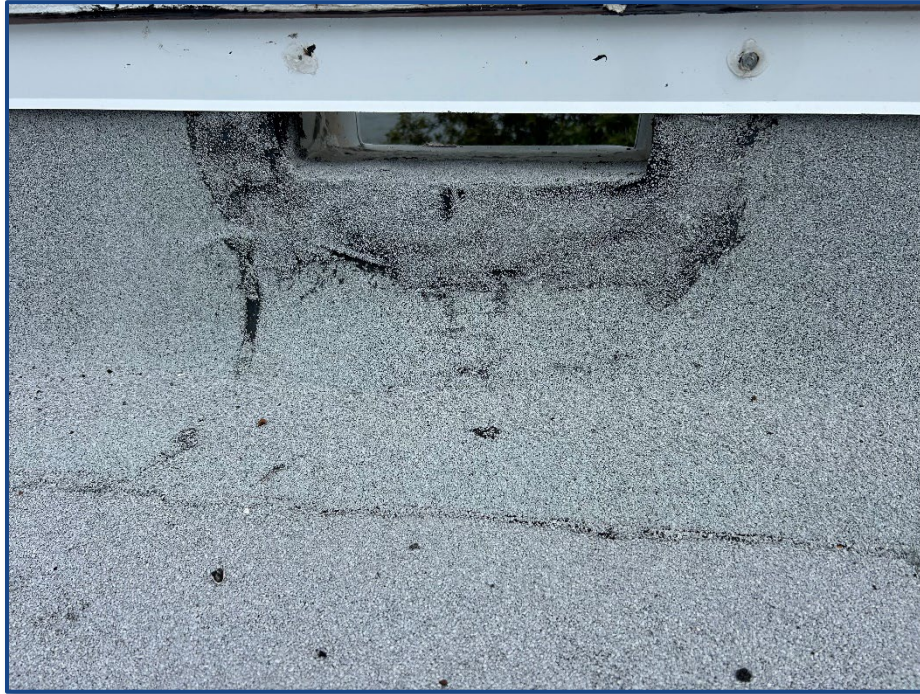
Photograph No. 13: Typical exterior roof scupper at the parapet wall.

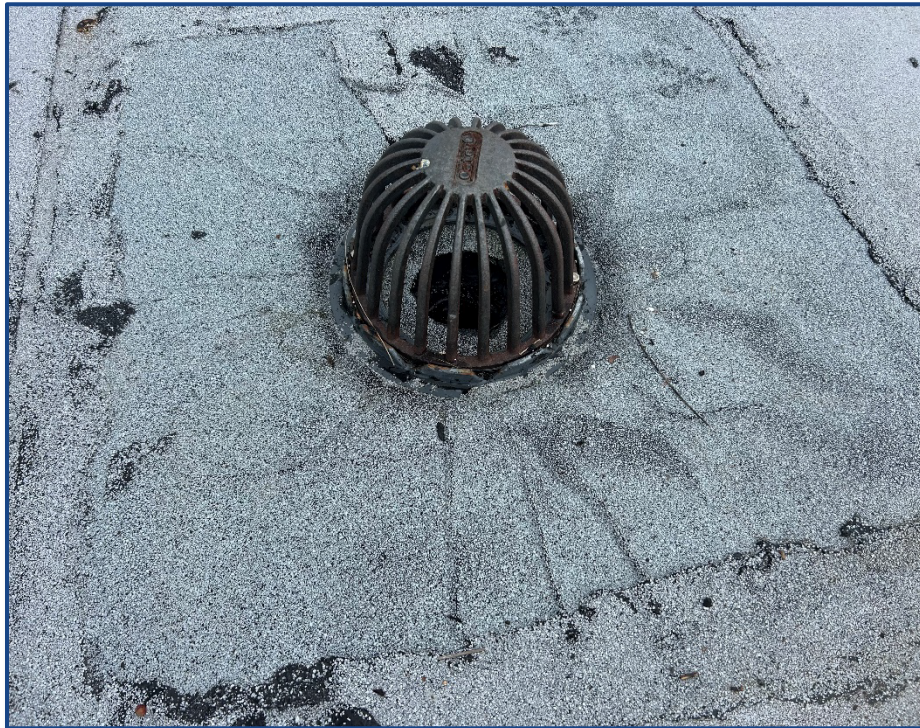
The building's roof system is composed of a flat roof with Bituminous BUR (built-up-roof) at the center flat area. The perimeter of the building has a sloped clay tile roof. Interior roof drains were observed in good condition at the center section of the roof. The Bituminous center section was redone in 2024 with 20 years of EUL remaining. The clay tiles are original construction with 40 years of EUL.

Photograph No. 14: Typical interior roof drain at the center of the roof.

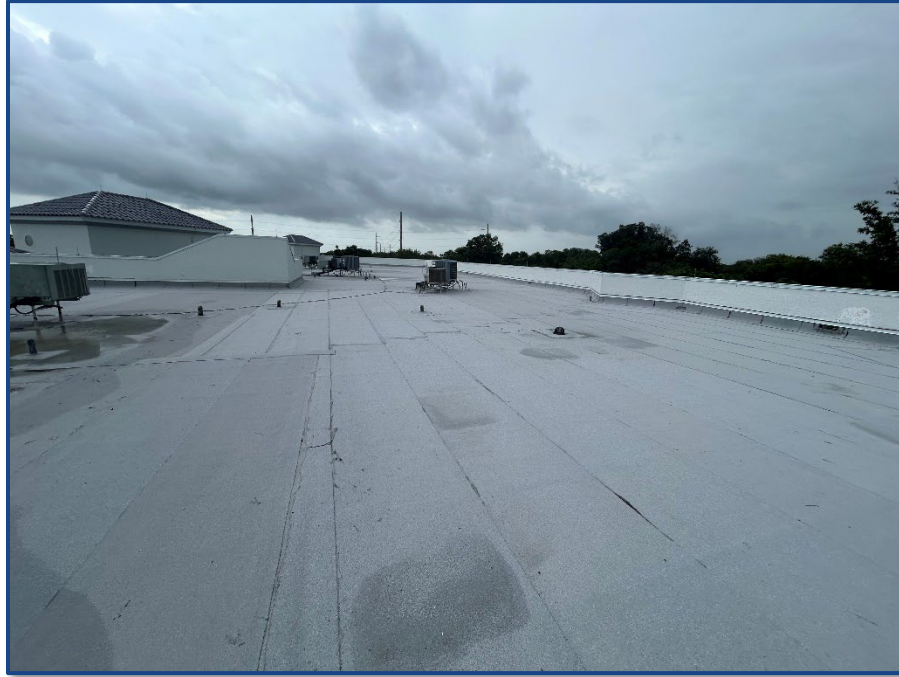
Photograph No. 15: Overall roof facing east.

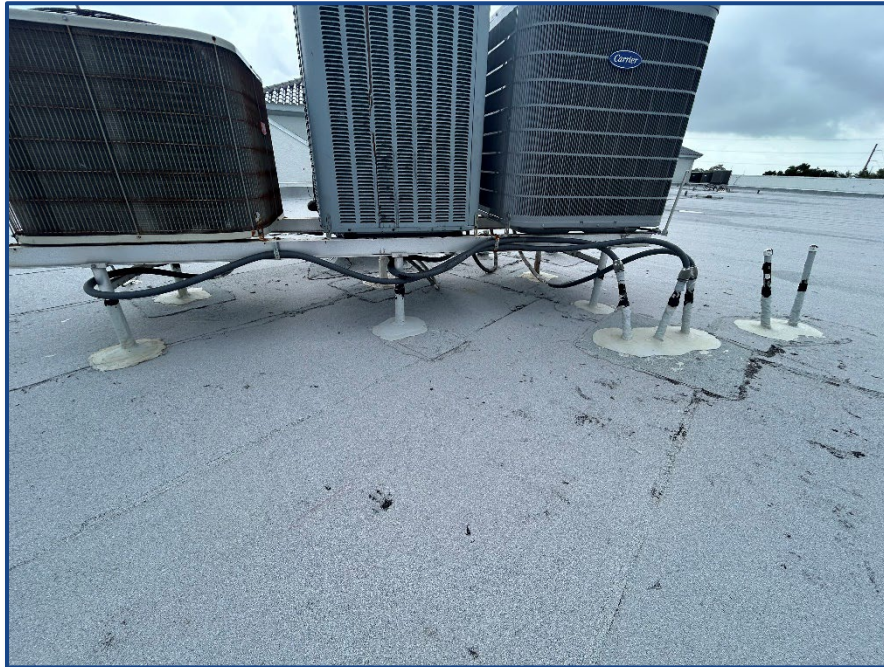
Photograph No. 16: AC stands mineral covered supports.

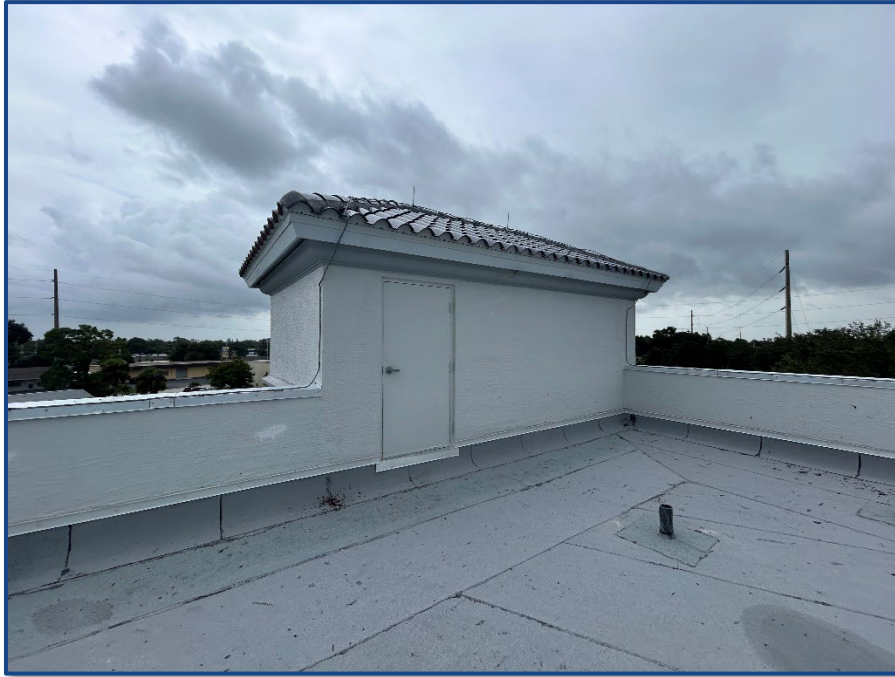
Photograph No. 17: Typical roof access from the stairwell at the east side of the roof.

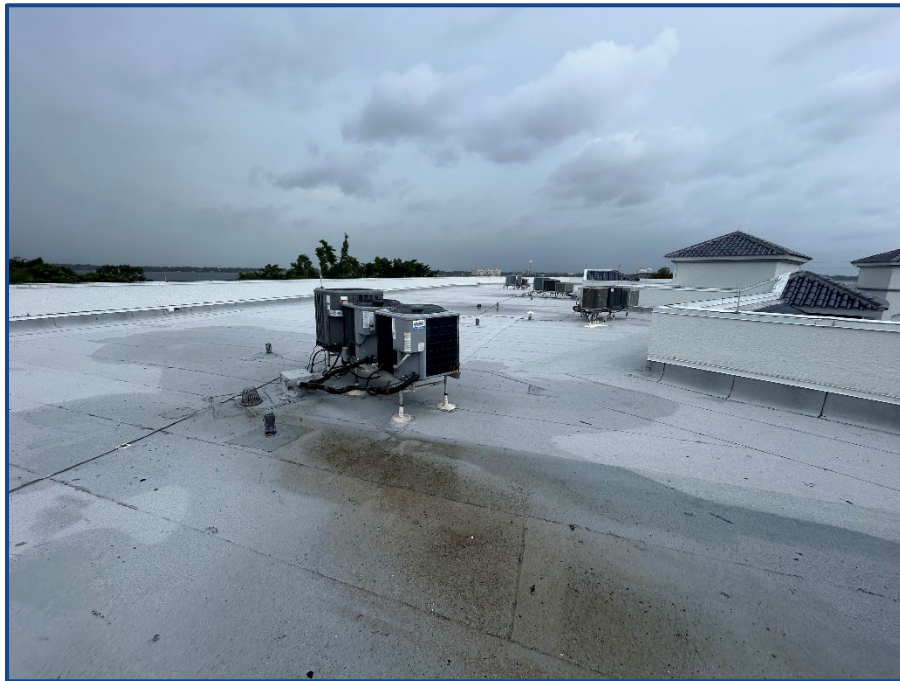
Photograph No. 18: Overall roof facing west in good condition.

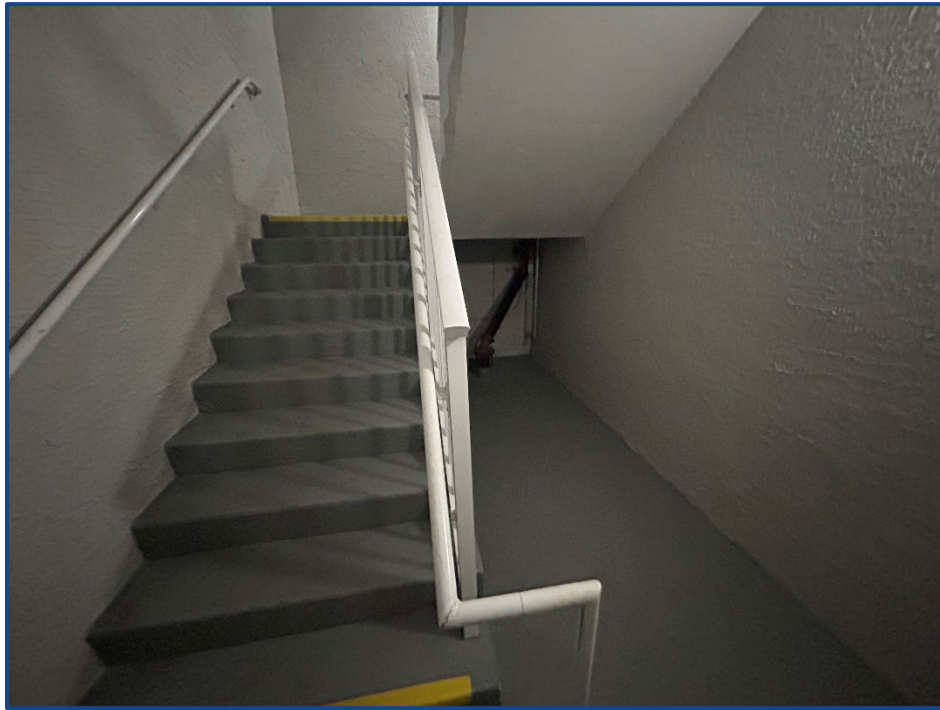
Photograph No. 19: Indoor stairwell located at the east side of the building.

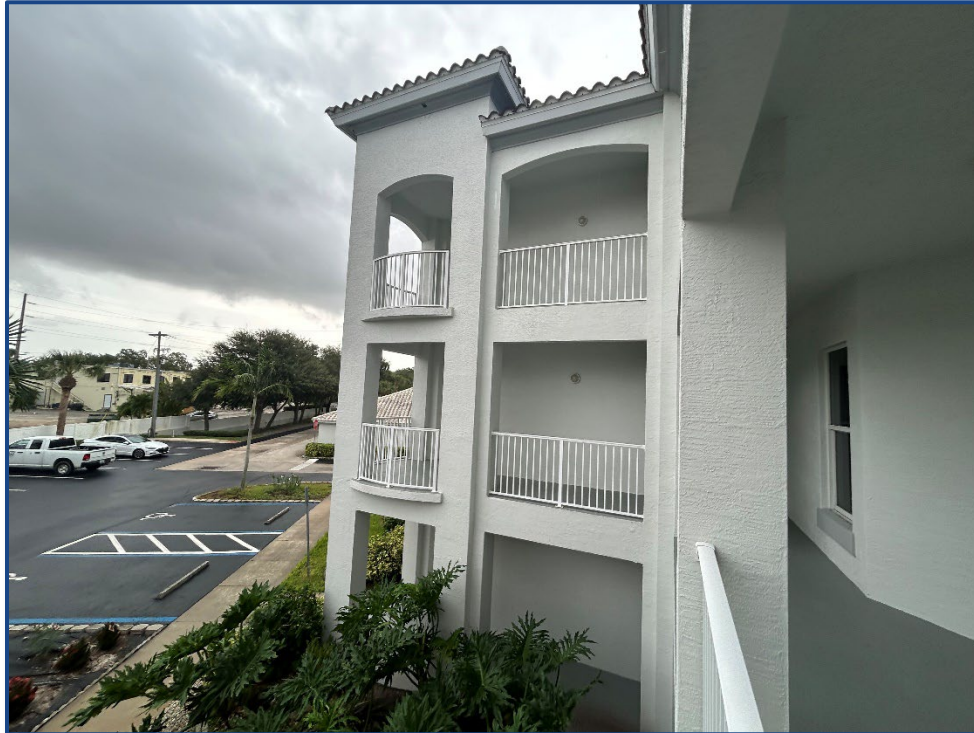
Photograph No. 20: Overview of outdoor walkways on the east side of the building.

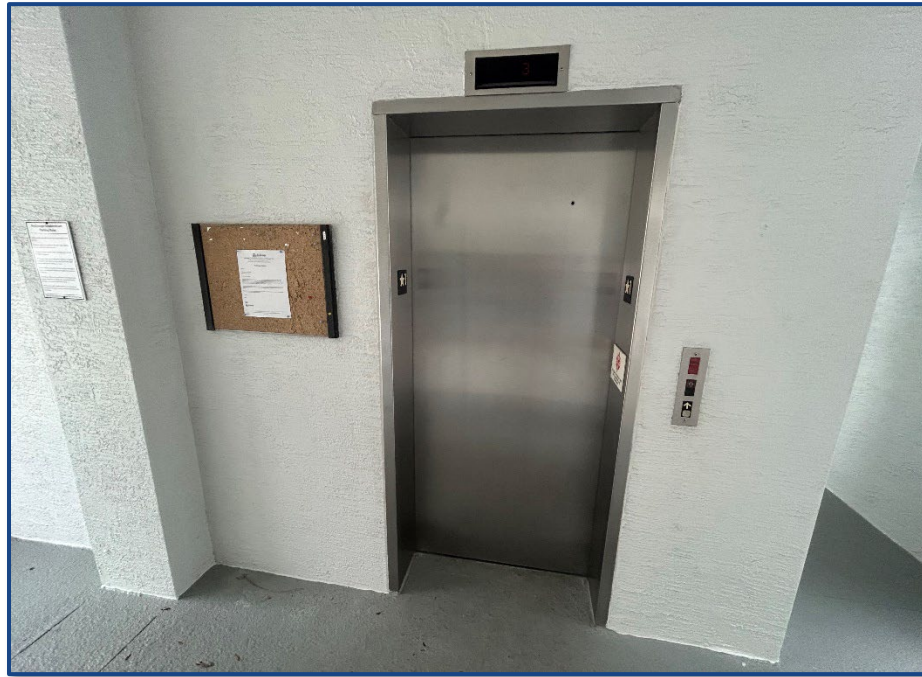
Photograph No. 21: Typical elevator door at center of building.

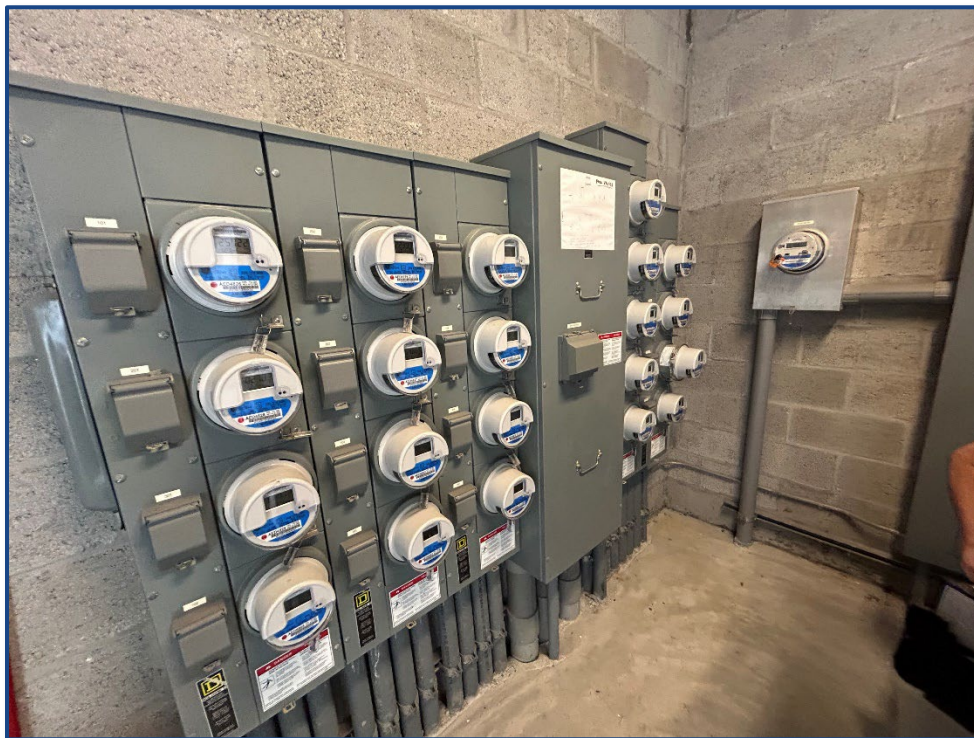
The visible electrical systems inspected at the time of inspection in the electrical room included the individual electrical meters and house panels. The main electrical service is 1000 Amp, 240 volt, 3 phase, 4 wire service to the main disconnect. All power consumption meters, line gutters and electrical conduits are inside the utility room at the north side of the building and are kept separate from the elements. At the time of inspection, no deficiencies were observed to the electrical systems. There may be other issues that may occur during the next 10 years, requiring some small maintenance reserves.

Photograph No. 22: Typical electrical meters and main service panel.

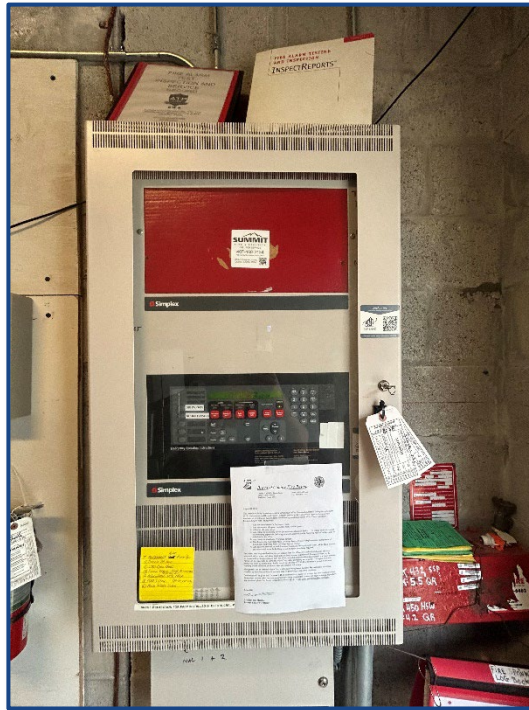
Photograph No. 23: Simplex Fire Alarm control panel located in the utility room.

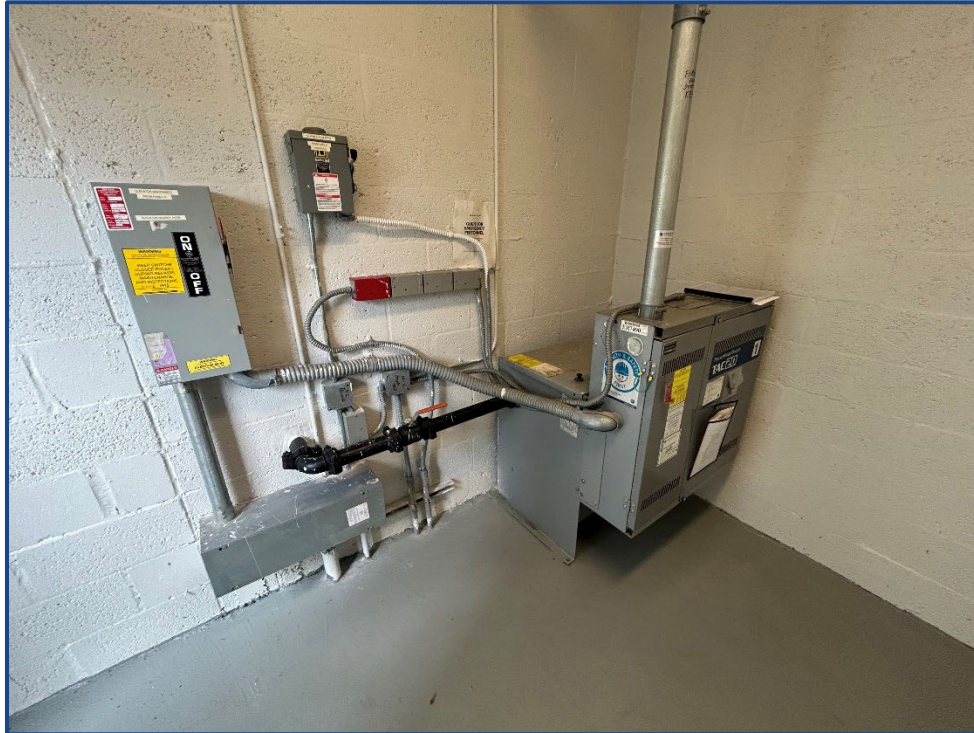
Photograph No. 24: Typical elevator hydraulic unit in the utility room.

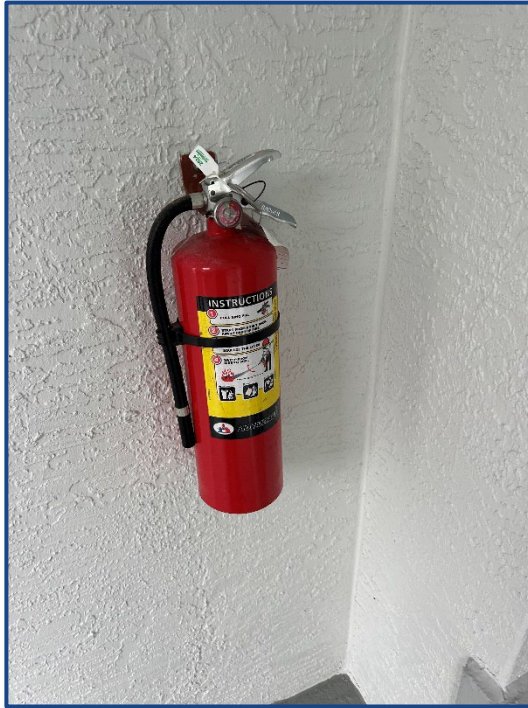
Photograph No. 25: Typical fire extinguisher located in walkway.

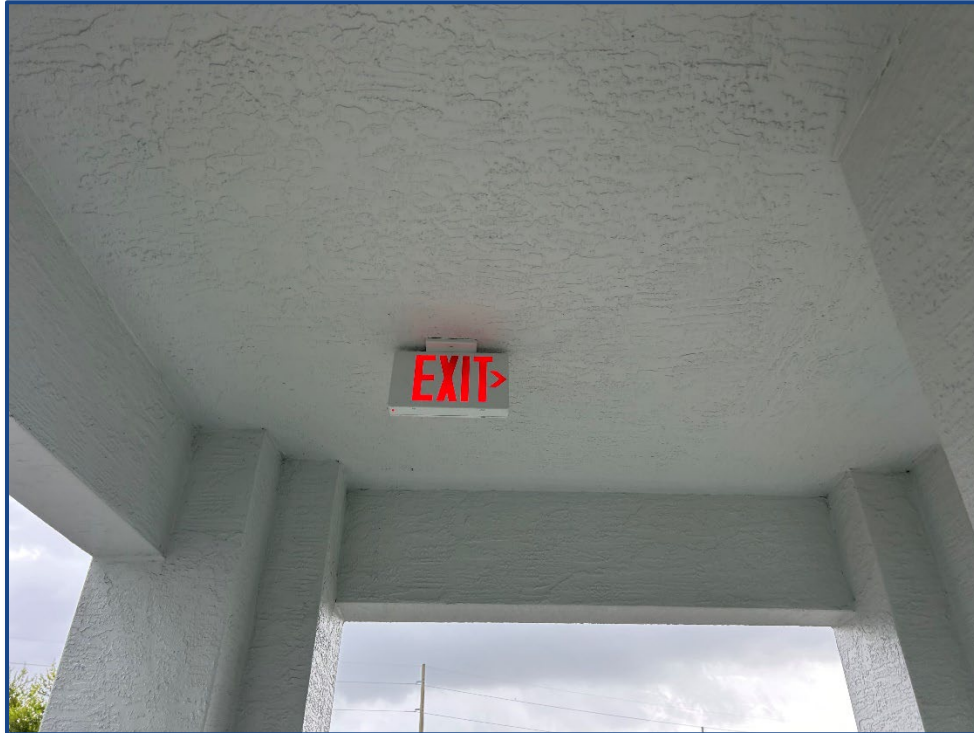
Photograph No. 26: Typical emergency exit signs located throughout walkway.

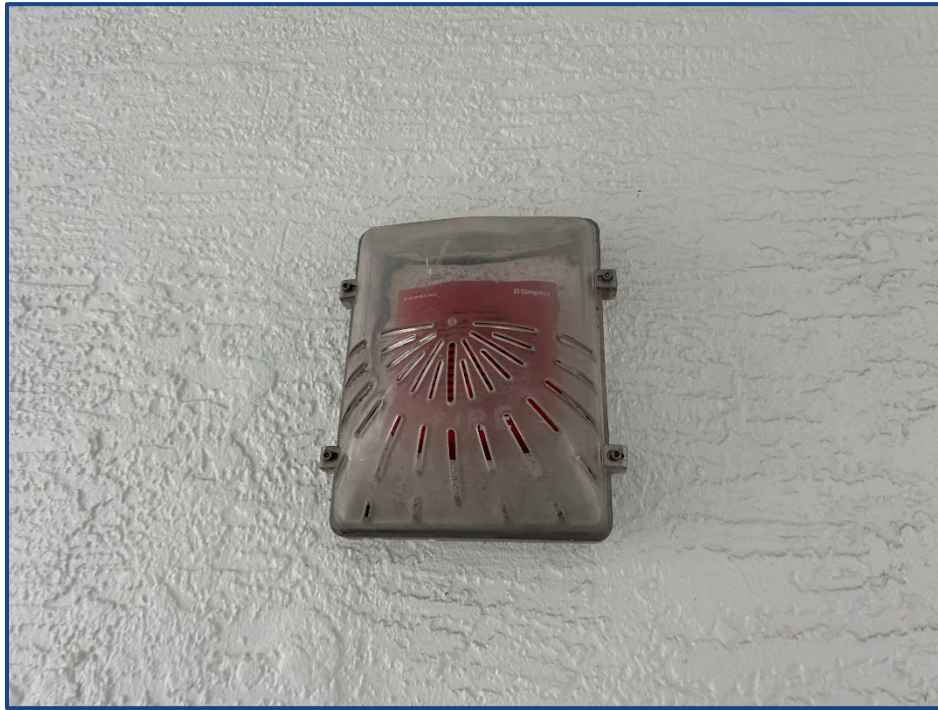
Photograph No. 27: Typical fire alarm located in walkway.

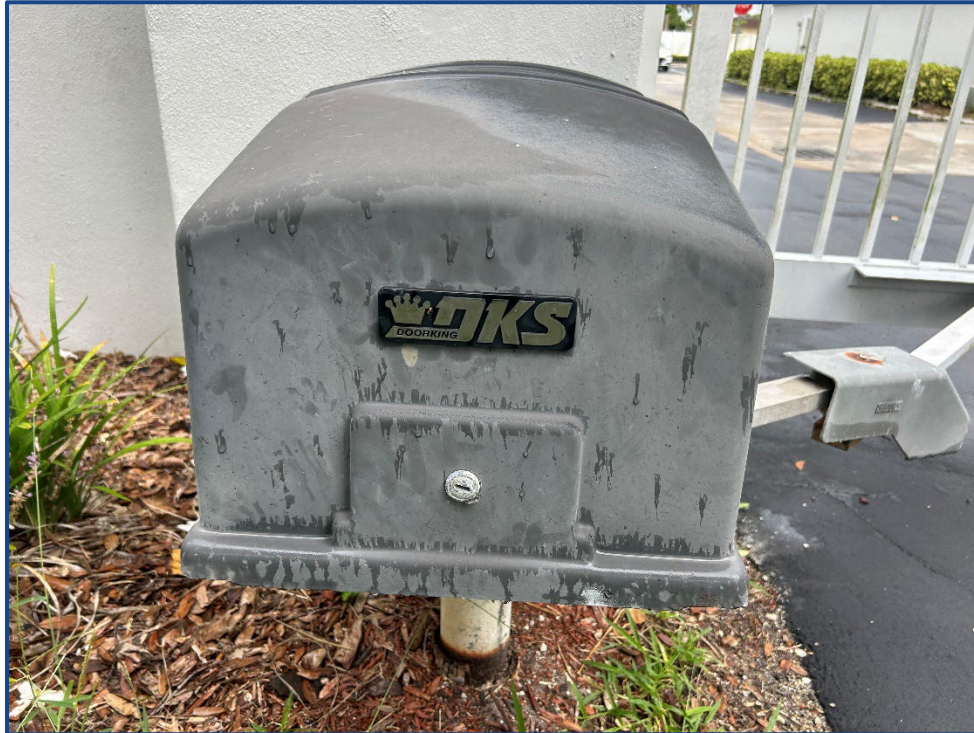
Photograph No. 28: Entrance gate motor at the south side of the property.
