## Uniform Mitigation Verification Inspection Form

| Inspection Date: 01/28/2021 | | |
| Owner Name: Anchorage Condominium Association | | Contact Person: |
| Address: 420 Moore Park Ln | | Home Phone: |

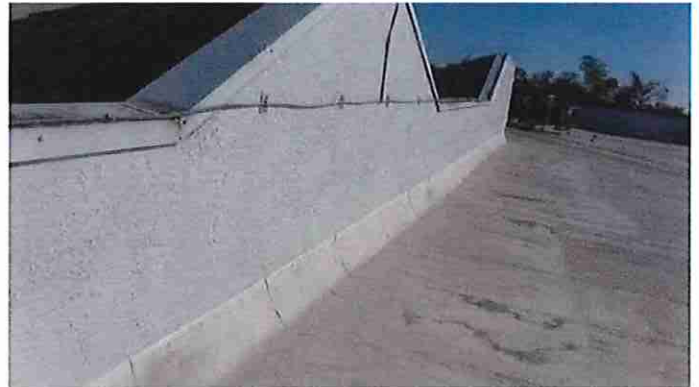
- ☒ E. Structural Anchor bolts structurally connected or reinforced concrete roof.  
☐ F. Other: \_\_\_\_\_  
☐ G. Unknown or unidentified  
☐ H. No attic access

Concrete roof decking structurally attached

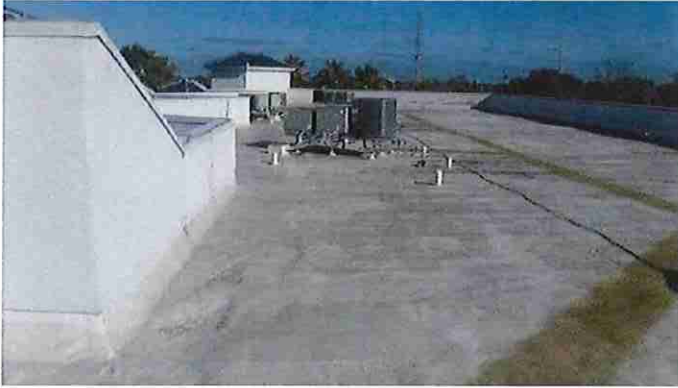
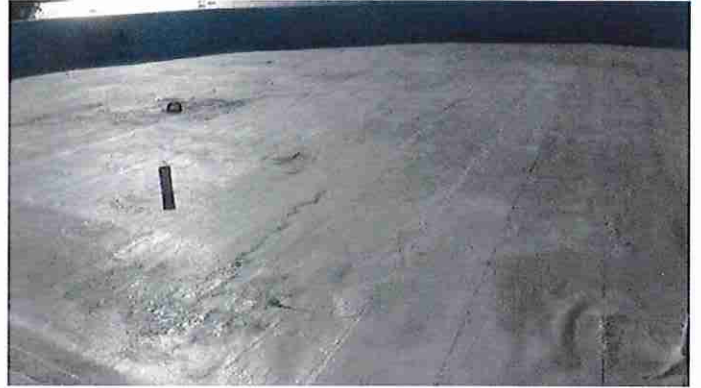
| 2.1 Roof Covering Type: | Permit Application Date | FBC or MDC Product Approval # | Year of Original Installation or Replacement | No Information Provided for Compliance |
|---|---|---|---|---|
| <input checked="" type="checkbox"/> 5. Membrane | ____/____/____ | _____ | Original 2004 | <input type="checkbox"/> |
| <input checked="" type="checkbox"/> 6. Other: Elastimeric coating | ____/____/____ | _____ | Approx. 2020 | <input type="checkbox"/> |

- ☐ A. Hip Roof Hip roof with no other roof shapes greater than 10% of the total roof system perimeter.  
 Total length of non-hip features: \_\_\_\_\_ feet; Total roof system perimeter: \_\_\_\_\_ feet  
☒ B. Flat Roof Roof on a building with 5 or more units where at least 90% of the main roof area has a roof slope of less than 2:12. Roof area with slope less than 2:12 \_\_\_\_\_ sq ft; Total roof area \_\_\_\_\_ sq ft  
☐ C. Other Roof Any roof that does not qualify as either (A) or (B) above.

Roof overview

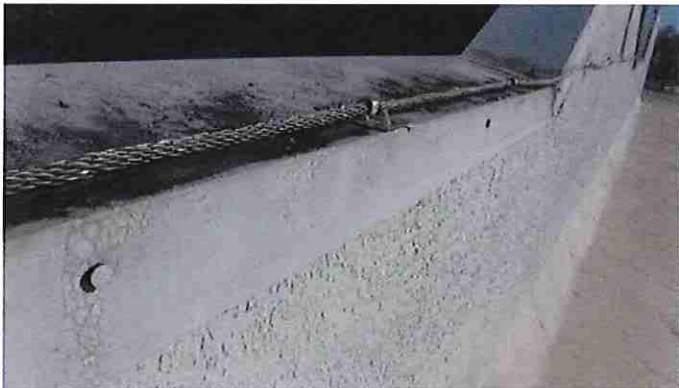
Mechanically fastened flashing

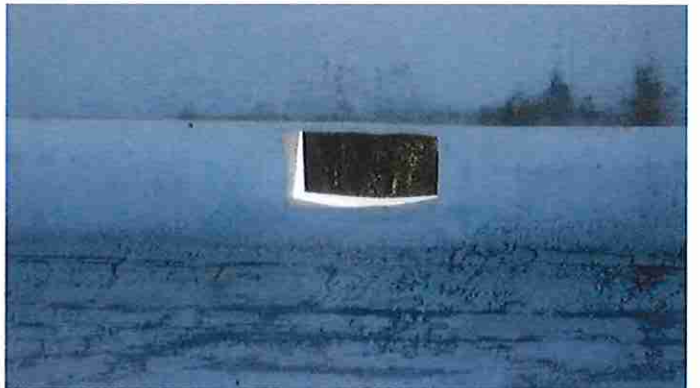
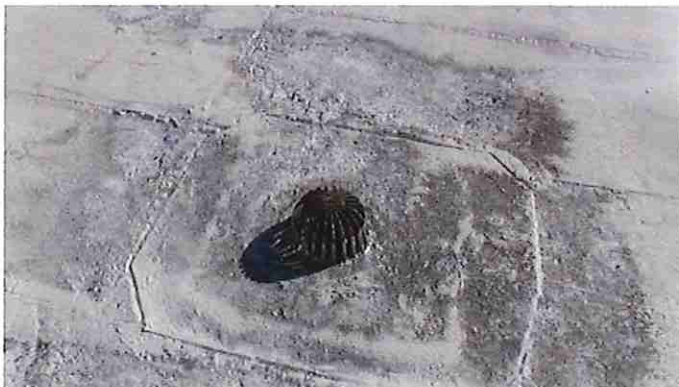
Drainage

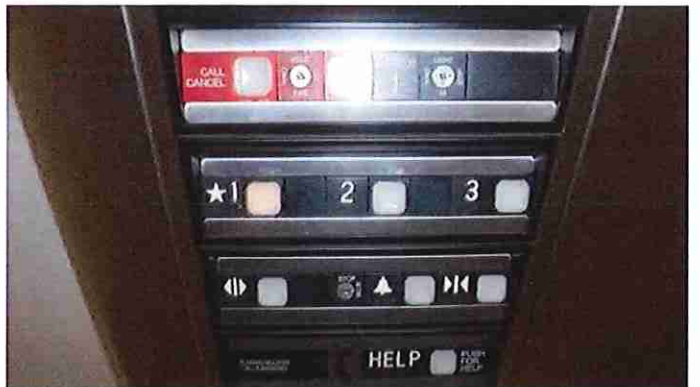
3 Stories
